# New York State Department of Transportation General Bridge Inspection Report

*Inspection Date:* October 30, 2025

*BIN:* 2227620

*Feature Carried:* LOFT ROAD

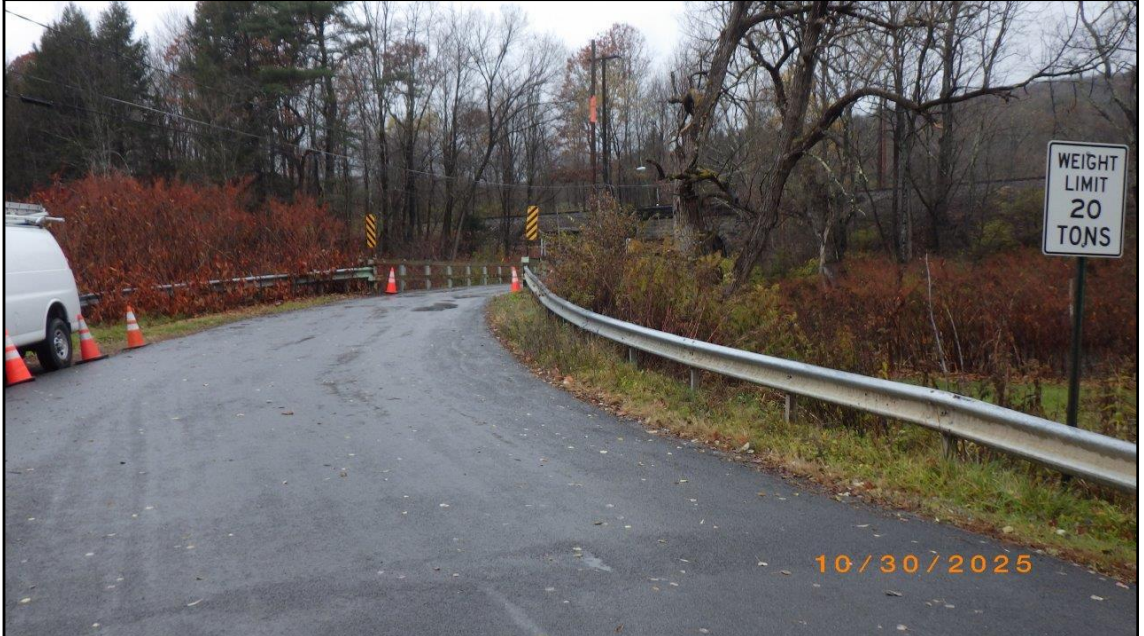
There are 20 Ton Load posting signs present at both approaches in good condition (Photos 1 & 2).

All bridge object markers have been replaced since the last inspection. The Dead End bridge sign is no longer obstructed (Photo 1 & 2). The end left approach railing the termination post has been replaced and now in good condition (Photo 32).

**Attachment Description:**  
Approach Begin, Looking  
End

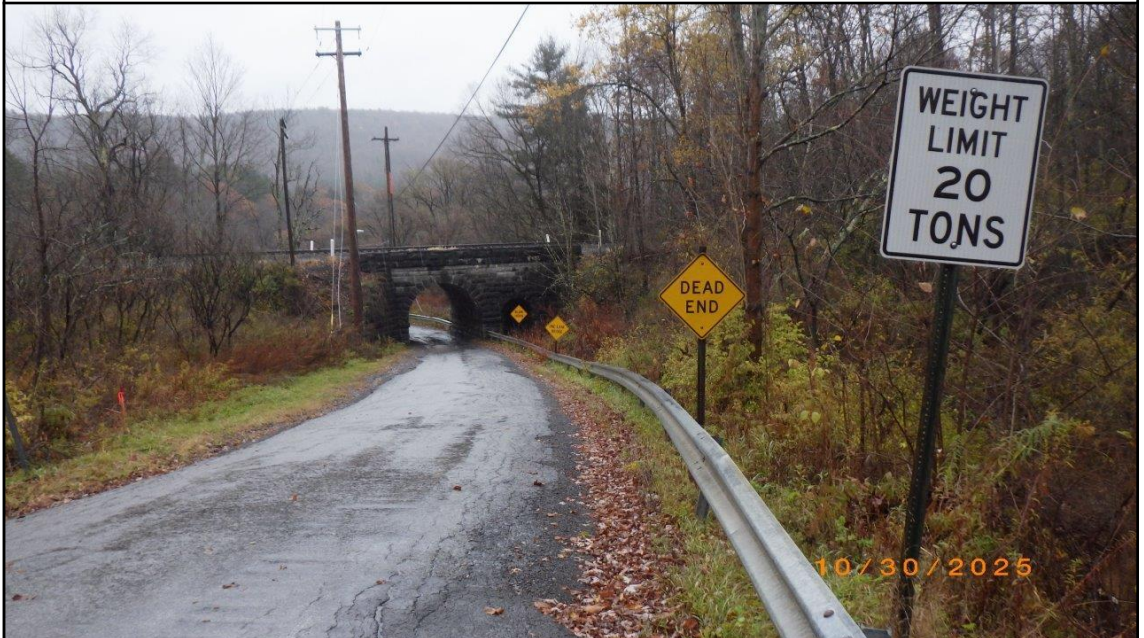
Photo Number: 2

**Attachment Description:**  
End Approach Load Posting  
Sign, Looking Begin

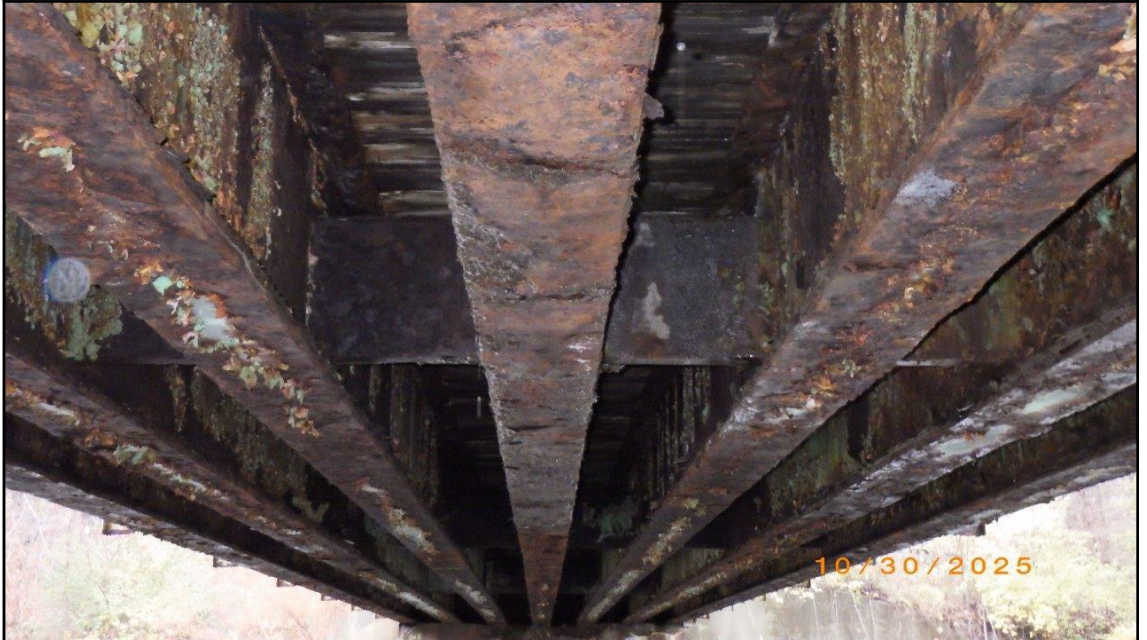
Photo Number: 3

All paint has failed on the girders, allowing aggressive corrosion and probable section loss to continue (Photo 3).

**Attachment Description:**  
Framing, At Begin, Looking  
End

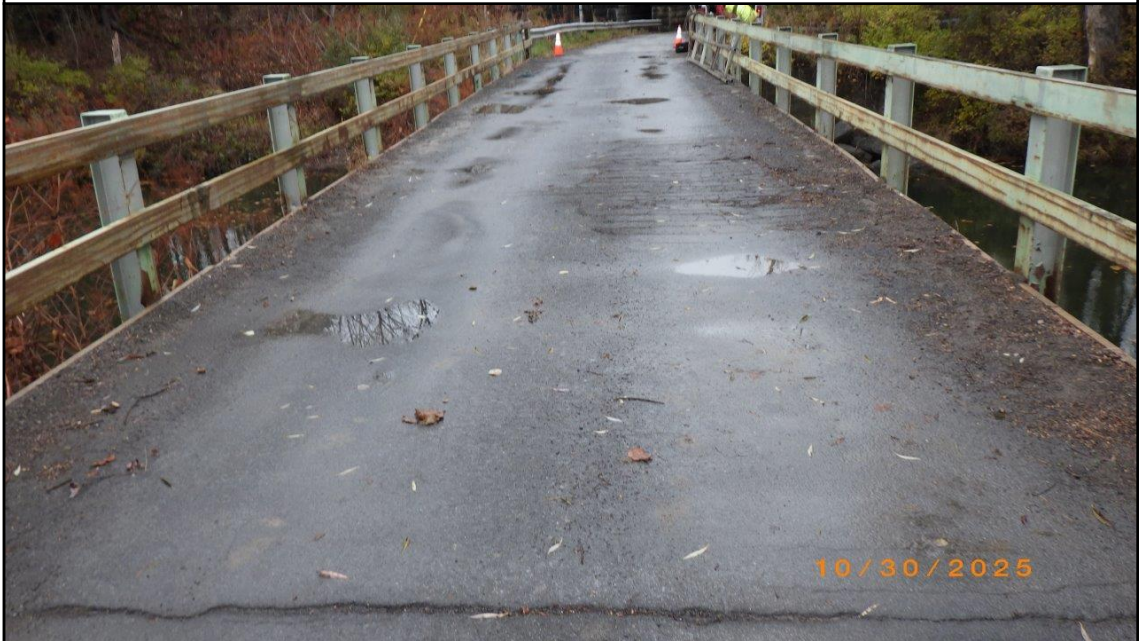
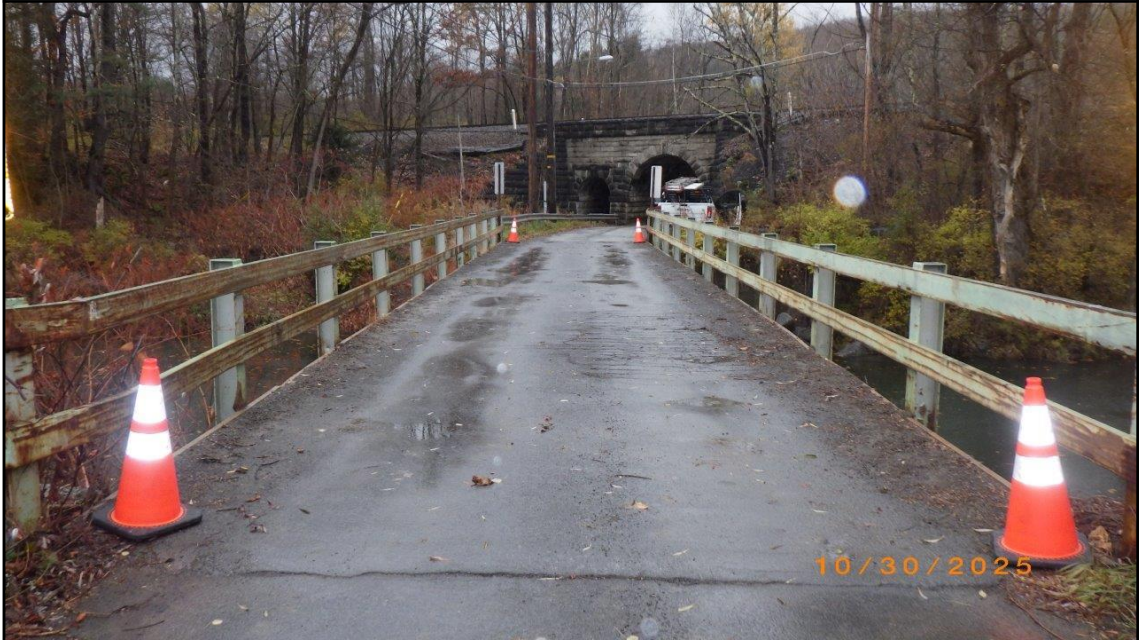
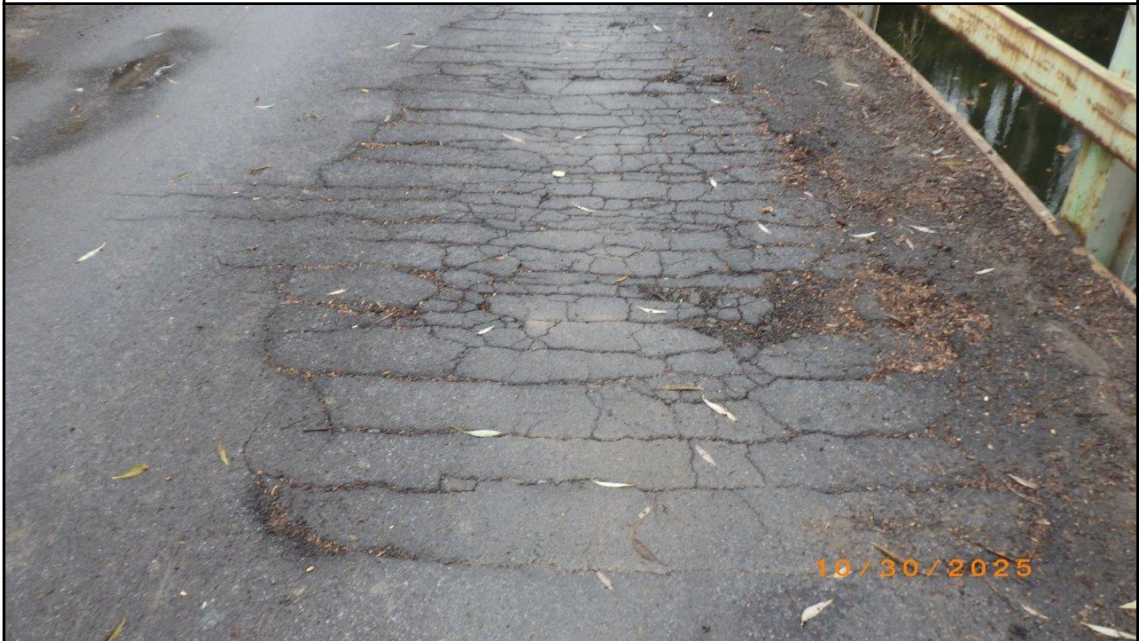
TQ	CS-1	CS-2	CS-3	CS-4	CS-5
<b>Span 1: 31 - Timber Deck</b>	1043	0	0	1043	0	0
<b>Condition State 3 Note</b>						
<b>Referenced Photo(s):</b> 3, 4, 5, 6, 7						
<b>Referenced Sketch(es):</b> None						
The entire deck underside is damp and water stained (Photo 3) due to open cracks in the wearing surface (Photos 4-6). More than half of the deck restraint clips are either missing or severely corroded as well.						
Approx 5% of the deck underside has light mold growth/ rot, with awl penetrations of 1" (Photo 7).						
The entire area of the deck is assessed at CS-3.						
<b>Span 1: 31 - Timber Deck-510 - Wearing Surfaces</b>	1021	0	0	868	153	0
<b>Common</b>						
<b>Referenced Photo(s):</b> 4, 5, 6						
<b>Referenced Sketch(es):</b> None						
<b>CS-4:</b>						
The asphalt wearing surface is heavily cracked on the right side near 1/3 span and at the end of the bridge resulting in moderating leakage of the deck (Photos 4-6).

CS-3:  
 The remainder of the wearing surface has unsealed transverse cracking that is up to 1/16" W (Photos 4-6)  
 No significant changes noted.

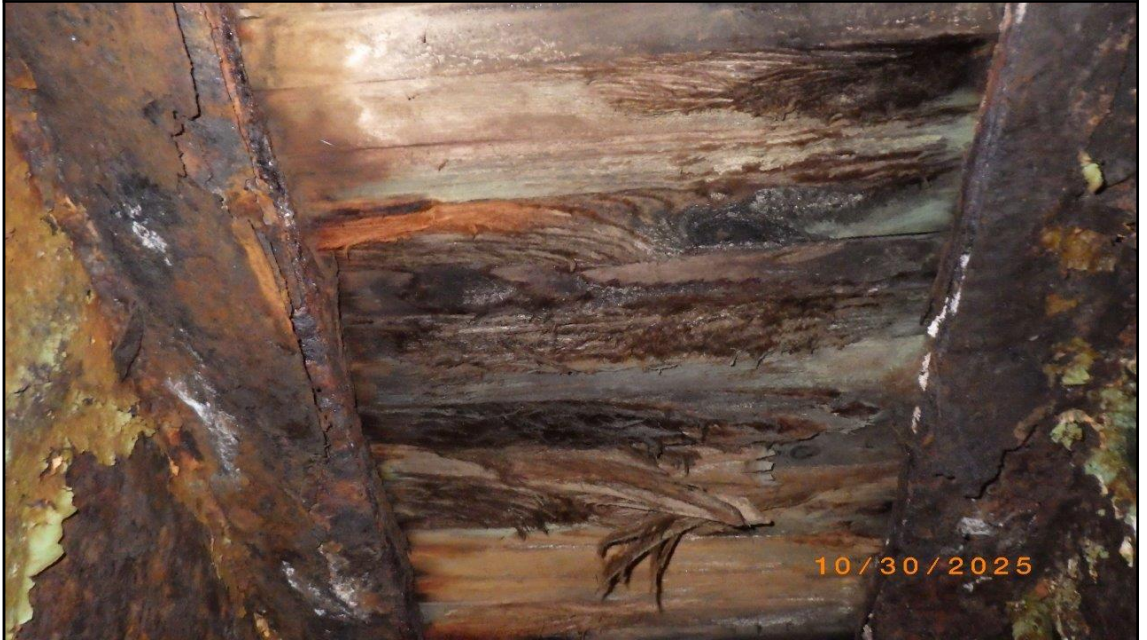
Photo Number: 7

**Attachment Description:**  
Underside of Deck, Bay 3,  
Near Begin Abutment,  
Looking Begin

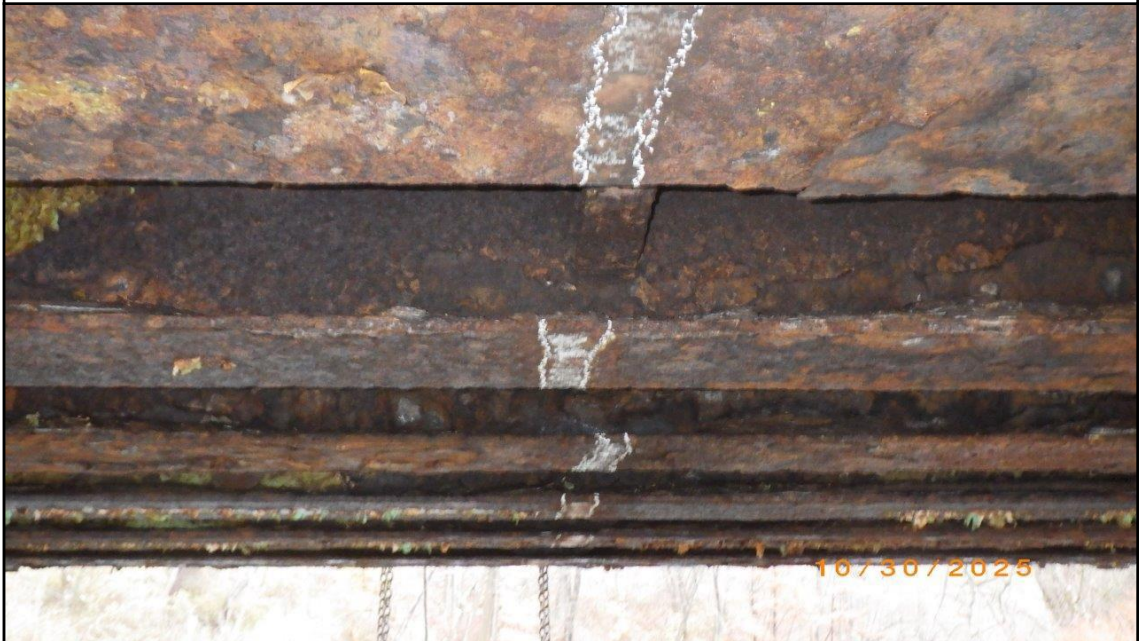
Photo Number: 8

The bridge is currently posted for 20 tons. There are significant long-standing section losses to the top and bottom flanges of all girders near midspan (Photo 8). No significant changes in readings since 2024. No flag is issued due to no change in load rating based on current section loss. See bottom flange section losses below and Sketches 2 & 3.

**Attachment Description:**  
Girders G2 to G7, Bottom  
Flanges, At Midspan,  
Looking Right

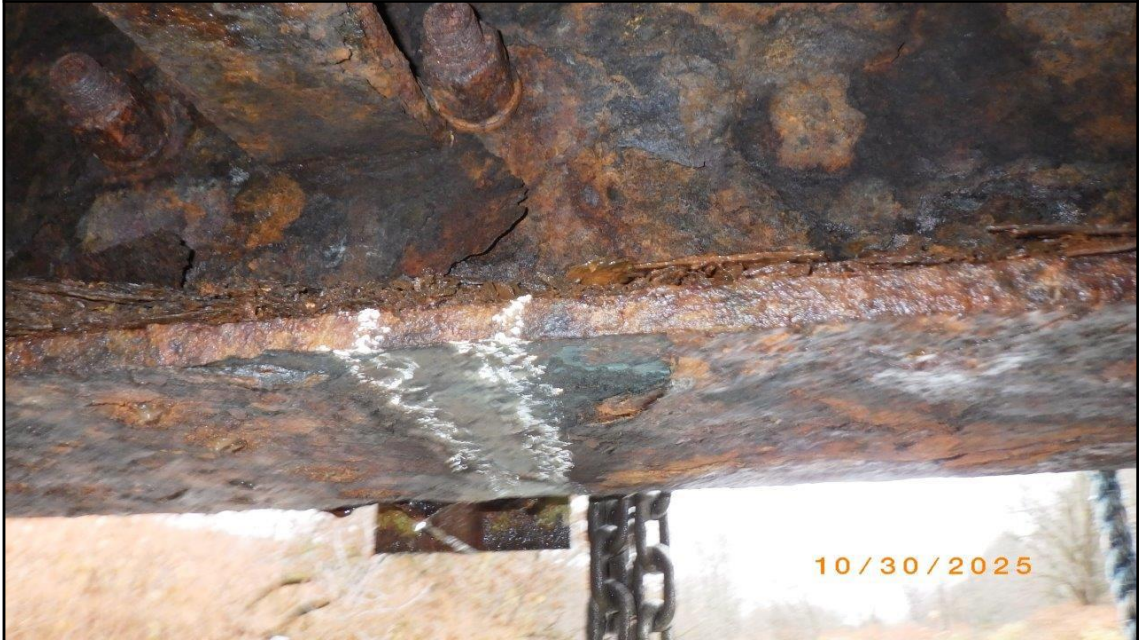
Photo Number: 9

- Girder G1: 43% SL (2024: 43%) (Photo 9).
- Girder G2: 28% SL (2024: 25%)
- Girder G3: 35% SL (2024: 34%)
- Girder G4: 42% SL (2024: 40%)
- Girder G5: 31% SL (2024: 30%)
- Girder G6: 32% SL (2024: 35%)
- Girder G7: 41% SL (2024: 41%)

**Attachment Description:**  
Girder G1, Bottom Flange,  
At Midspan, Looking Left

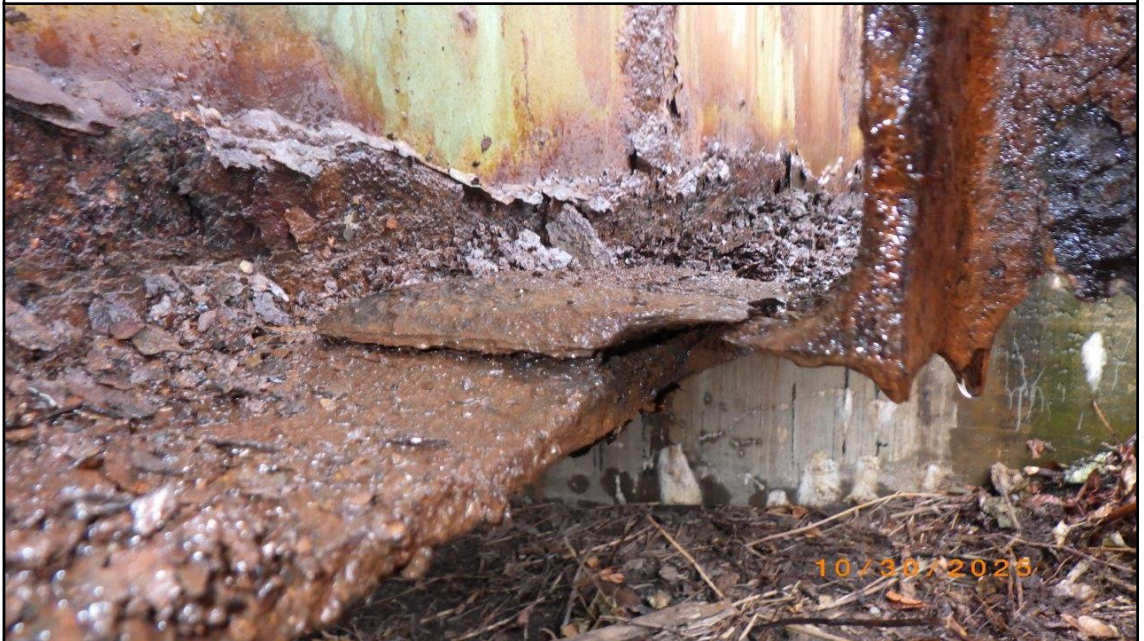
Photo Number: 10

In addition, there are cracked welds at the railing clip angle to fascia girder bottom flange connection at six separate locations (Photo 10). No obvious signs of crack propagation into the base metal noted this inspection. See Yellow Flag 9B25V2W046 for details.

See Yellow Flag 9B25V2W046 for Long-standing and newly reported cracked connection welds between bridge rail post clip angle brackets and fascia girder bottom flanges, in tension zones of the girders (Photo 10).

**Attachment Description:**  
Left Bridge Rail Post 3, End  
Side, Looking Begin

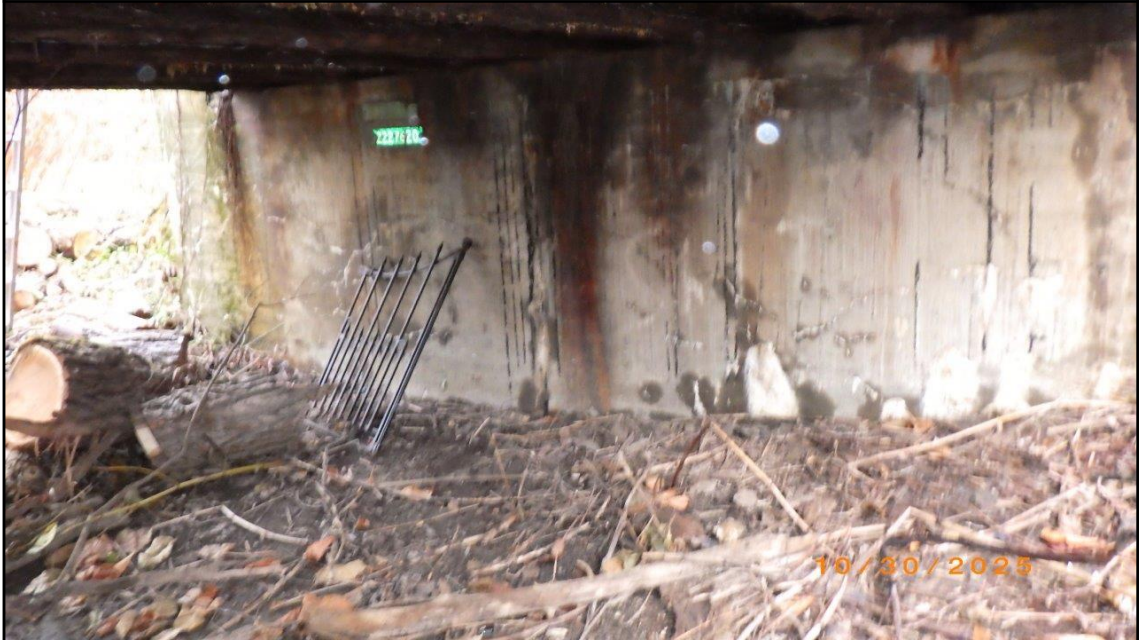
Photo Number: 11

Approximately half the length of the begin stem and wingwalls have map cracking with moderate efflorescence and scattered hollow sounding areas (Photo 11).

**Attachment Description:**  
Begin Abutment, Between  
Girder G1 to G7, Looking  
Begin

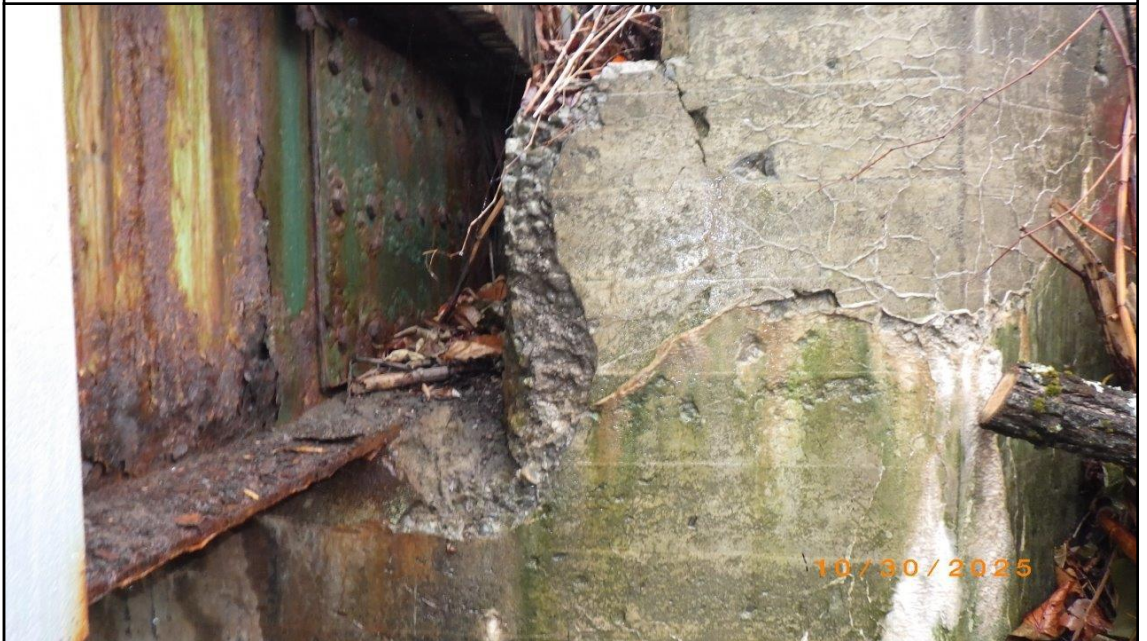
Photo Number: 12

To the left of Girder G1 there is a spall 1' long x up to 2' high up to 2" deep (Photo 12). Also, the top of the left wingwall is spalled 2' long x 1' wide x 1.5" deep (Photo 13)

**Attachment Description:**  
Begin Abutment, Left of  
Girder G1, Looking Begin

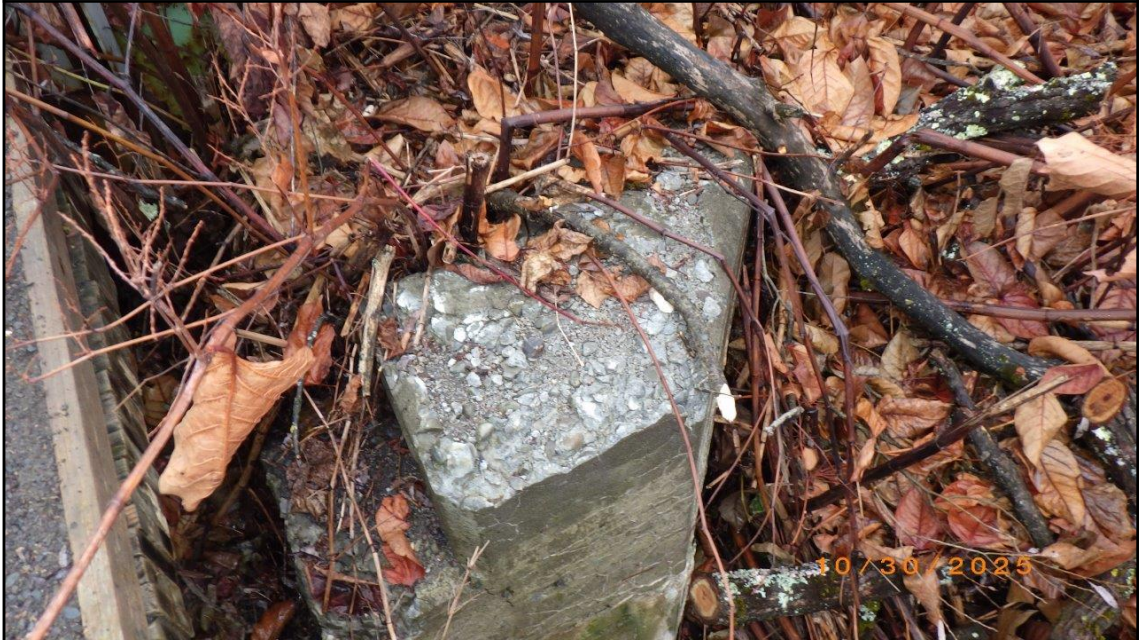
Photo Number: 13

**Attachment Description:**  
Begin Abutment Left  
Wingwall, Looking Begin

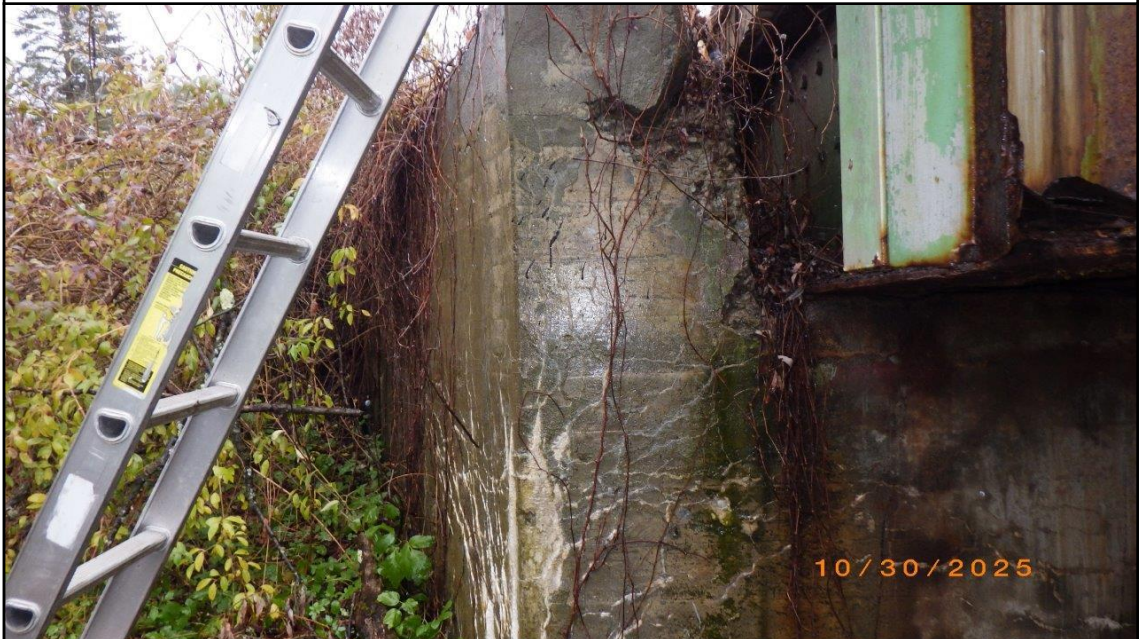
Photo Number: 14

To the right of Girder G7 there is a spall 1' long x up to 1.5' high up to 2" deep (Photo 14).

**Attachment Description:**  
Begin Abutment, Right of  
Girder G7, Looking Begin

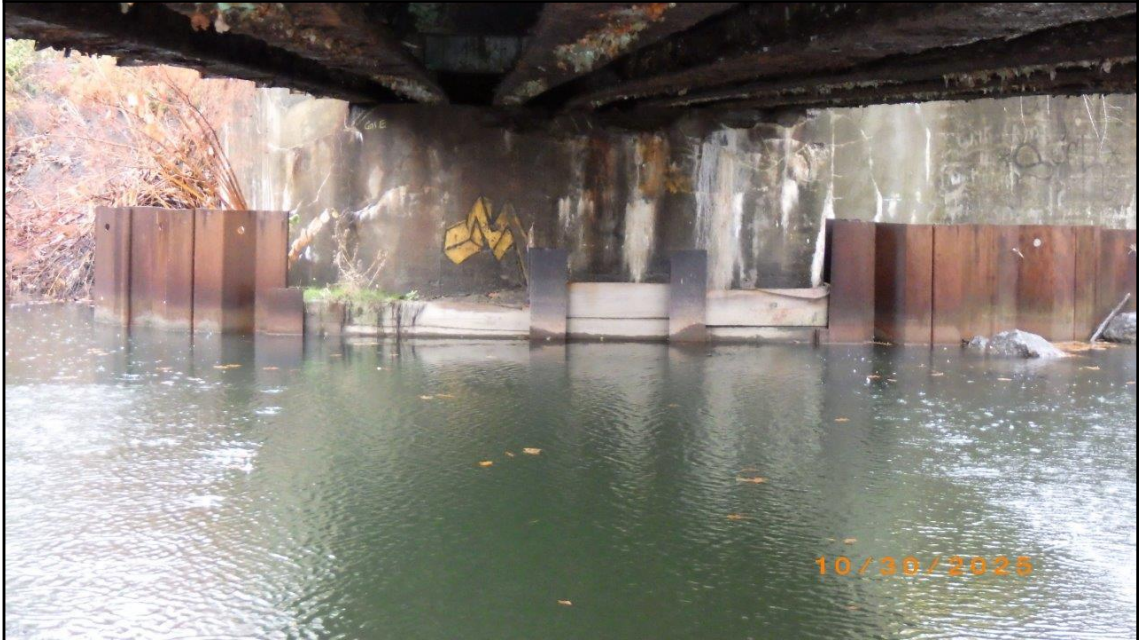
Photo Number: 15

The end stem and left wingwall portion have map cracking with moderate efflorescence and scattered hollow sounding areas (Photo 15).

All footings are buried with no history of defects and no current indirect indicators of distress. Rating for all footings is changed to CS1 (Photo 15 & 19).

**Attachment Description:**  
End Abutment, Looking End

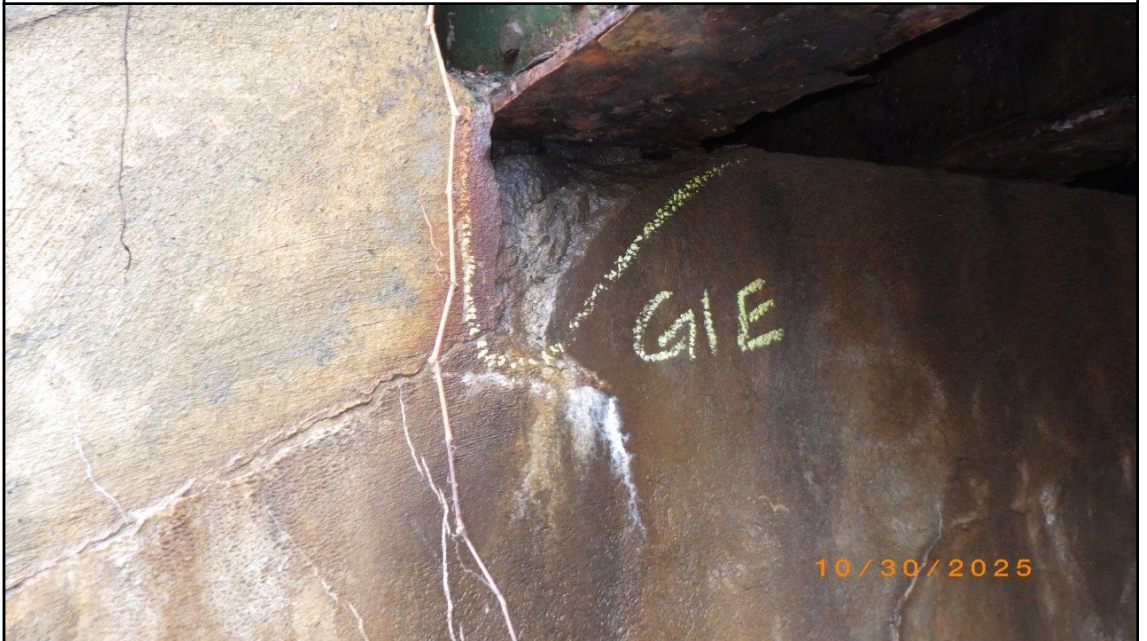
Photo Number: 16

Below Girder G1 there is a spall 1' long x 8" high x 2.5" deep (Photo 16). This spall effects the pedestal.

**Attachment Description:**  
End Abutment, At Girder  
G1, Looking End

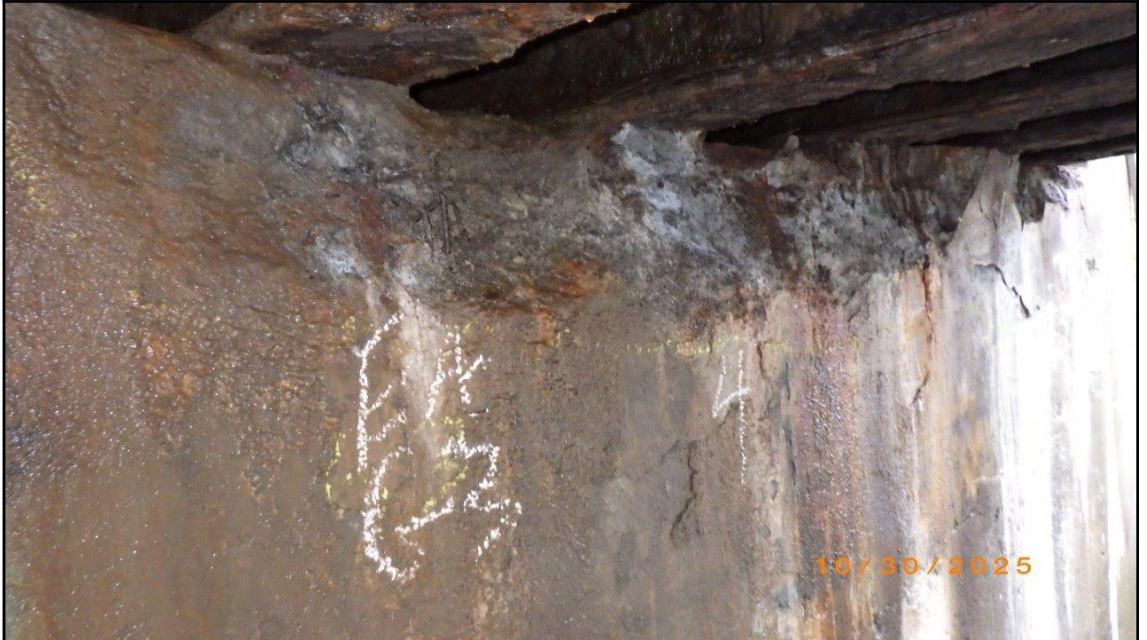
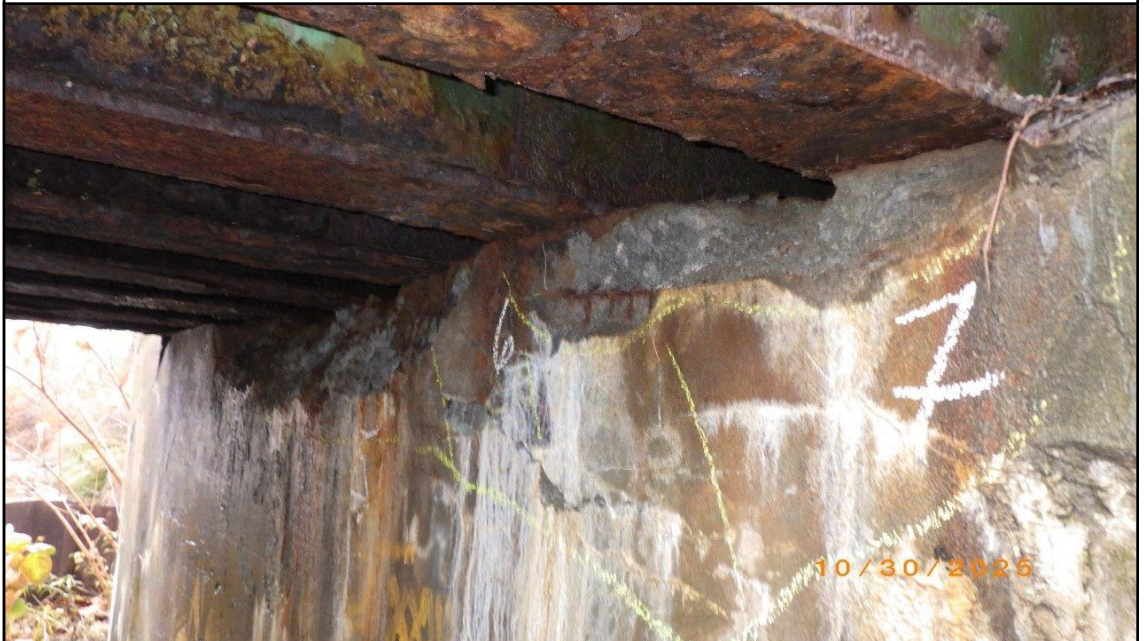
Below Girders G3 to G7 there is a spalled 10.5' long x13" high x up to 9 inches deep with exposed and corroded welded wire mesh (Photos 17 & 18). Concrete within this area is hollow-sounding. Girder G3 to G7 pedestals are effected.

The entire length of both backwalls are assessed at CS-3.						
<b>Span 1: EA851 - Abutment Pedestal</b>	7	0	1	6	0	0
<b>Condition State 3 Note</b>						
<i>Referenced Photo(s):</i> 16, 17, 18						
<i>Referenced Sketch(es):</i> None						
See EA215 - Reinforced Concrete Abutment for condition note (Photos 16-18).						
A total of 6 pedestals are assessed at CS-3.

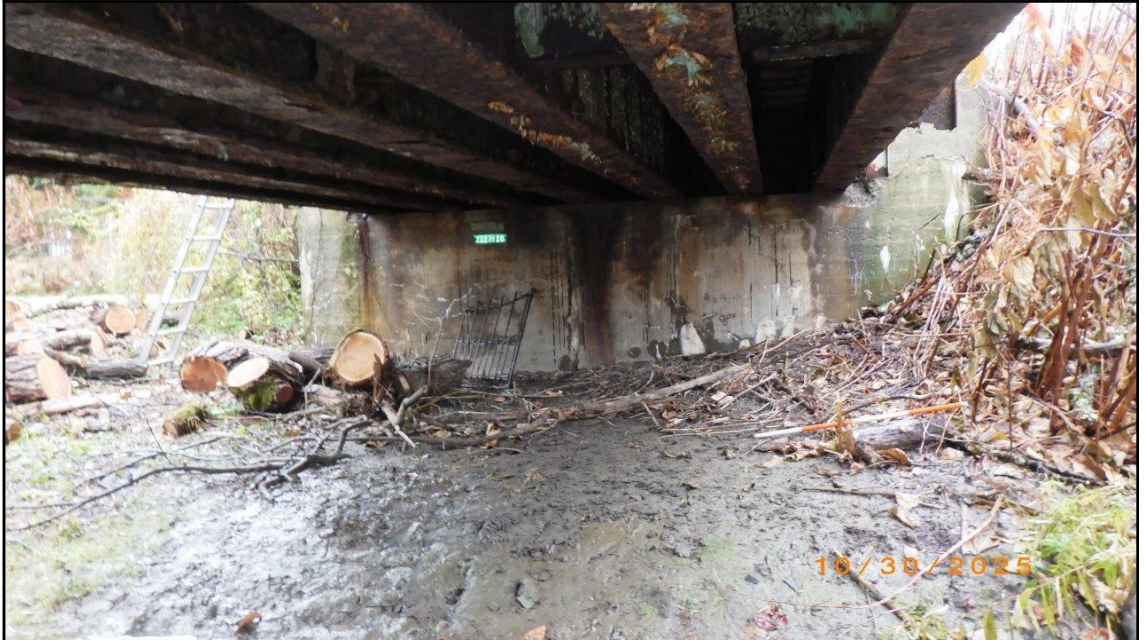
Photo Number: 19

**Attachment Description:**  
Abutment Begin, Looking  
Begin

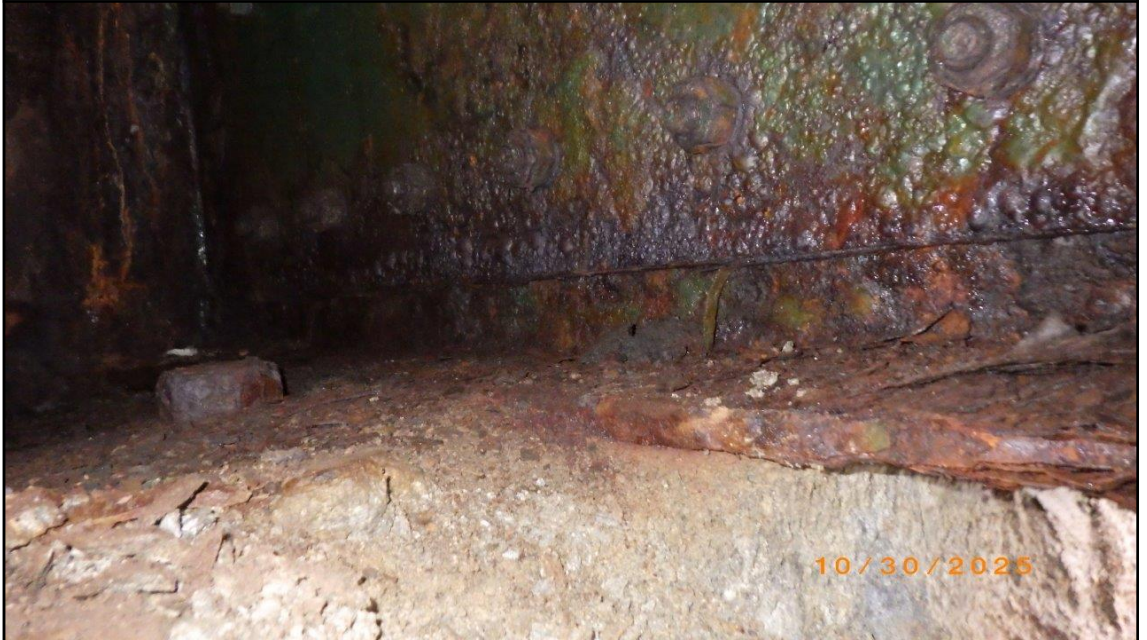
All paint has failed on the end abutment bearings, allowing corrosion to form (Photo 21).

**Attachment Description:**  
End Abutment Girder G7  
Bearing, Looking End Right

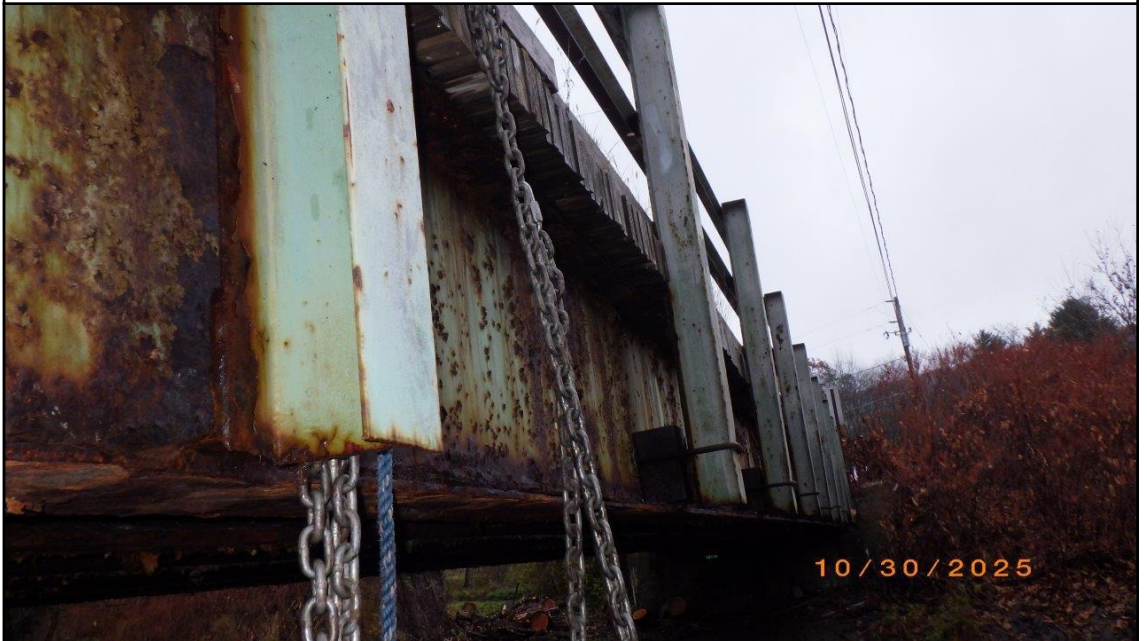
All posts have section loss at the base and along the bridge side flange up to 50% (Photo 22).

**Attachment Description:**  
Left Bridge Railing Posts, At  
End Looking Begin Right

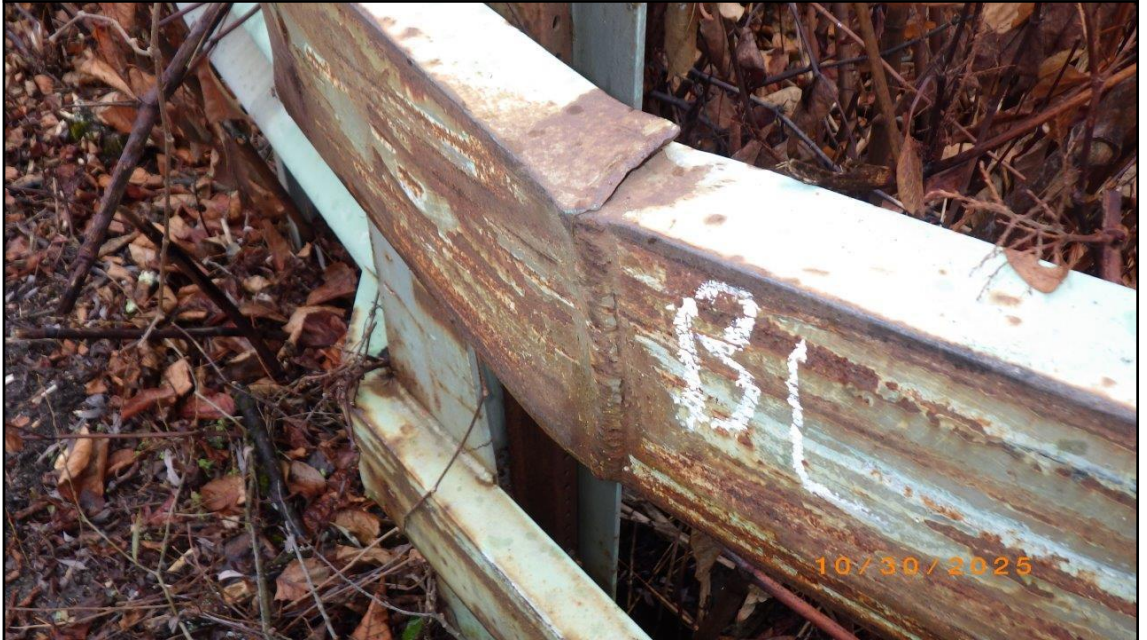
Photo Number: 23

The left bridge railing above the deck at the begin left the top post railing weld is cracked (Photo 23).

**Attachment Description:**  
Metal Bridge Railing, At  
Begin Left, Looking Left

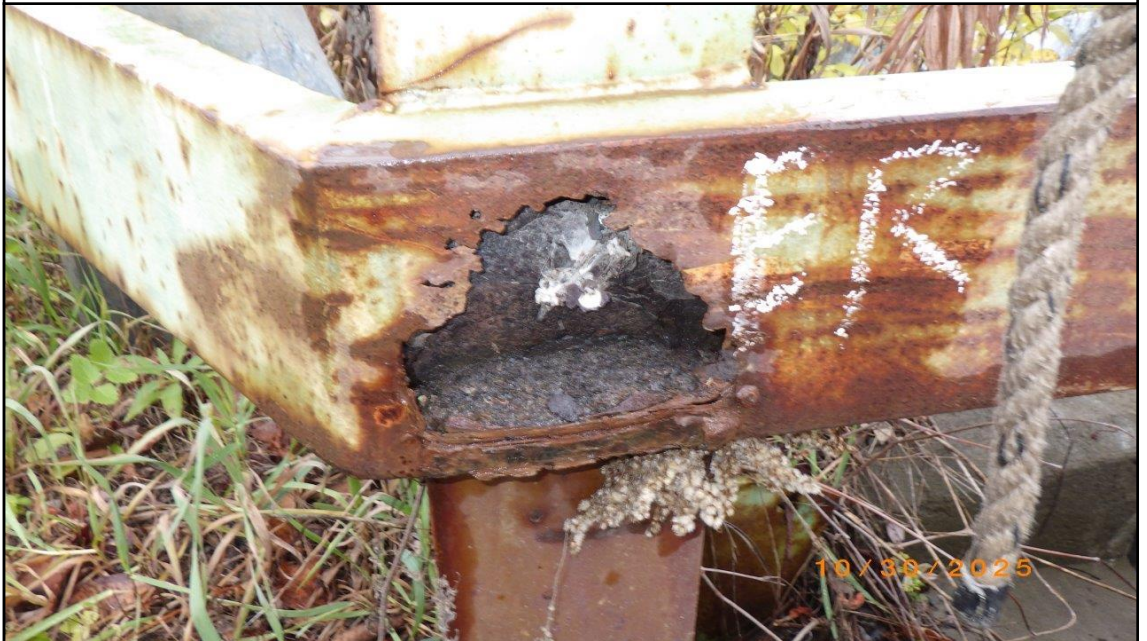
Photo Number: 24

The left and right bridge railing above deck bottom railing at the end exhibits perforation measuring 6" diameter (Photo 24).

**Attachment Description:**  
Metal Bridge Railing, At End  
Right. Looking Right

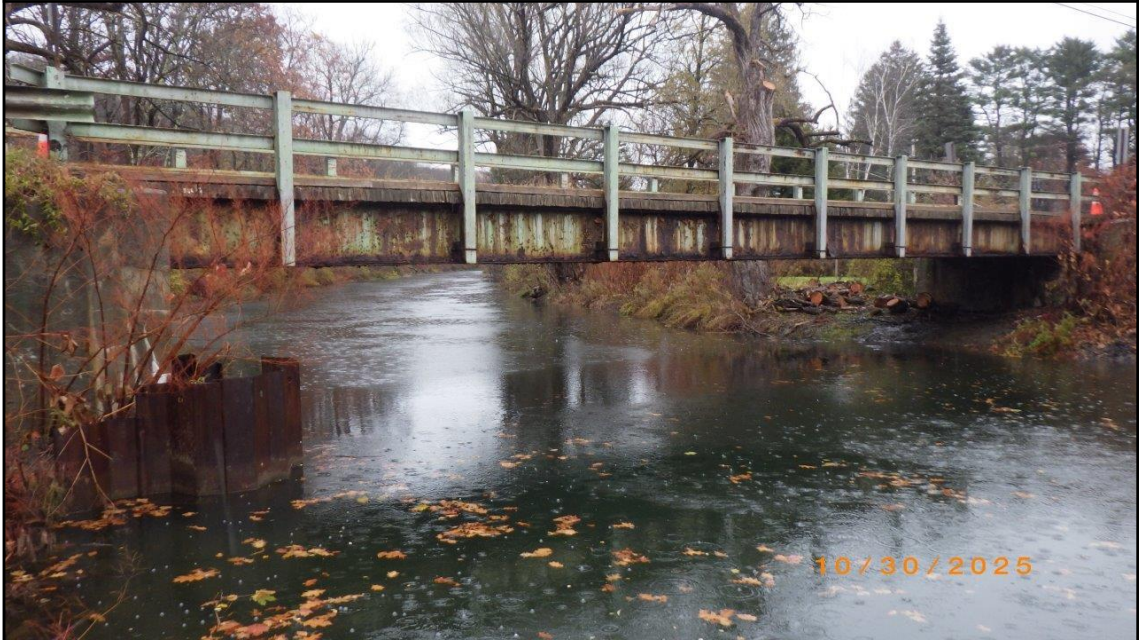
Photo Number: 25

**Attachment Description:**  
Elevation Left, Looking  
Right

The stream alignment is directed towards the end right stream bank and along the end abutment stem (Photo 25). The poor alignment has caused end left and right bank erosion (Photo 26 & 27) and a large scour hole beneath the bridge within the end 2/3 of the channel (see Channel Cross Section sketches).

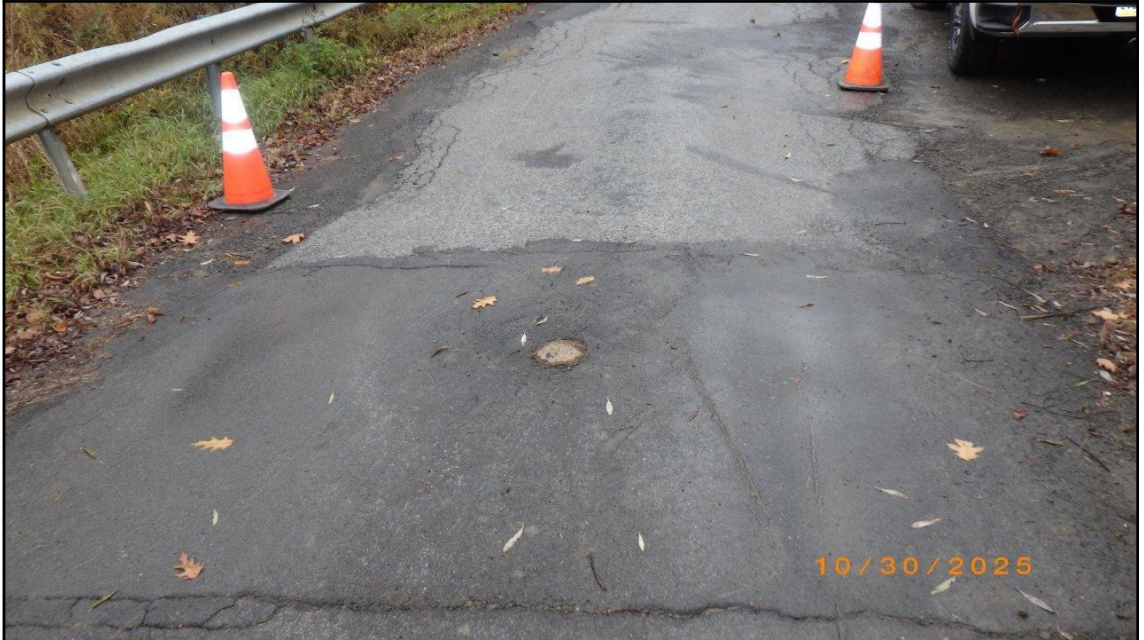
The end approach pavement is heavily cracked, and there was significant ponding at the end right shoulder area (Photo 31).

**Attachment Description:**  
Approach End Pavement,  
Looking End

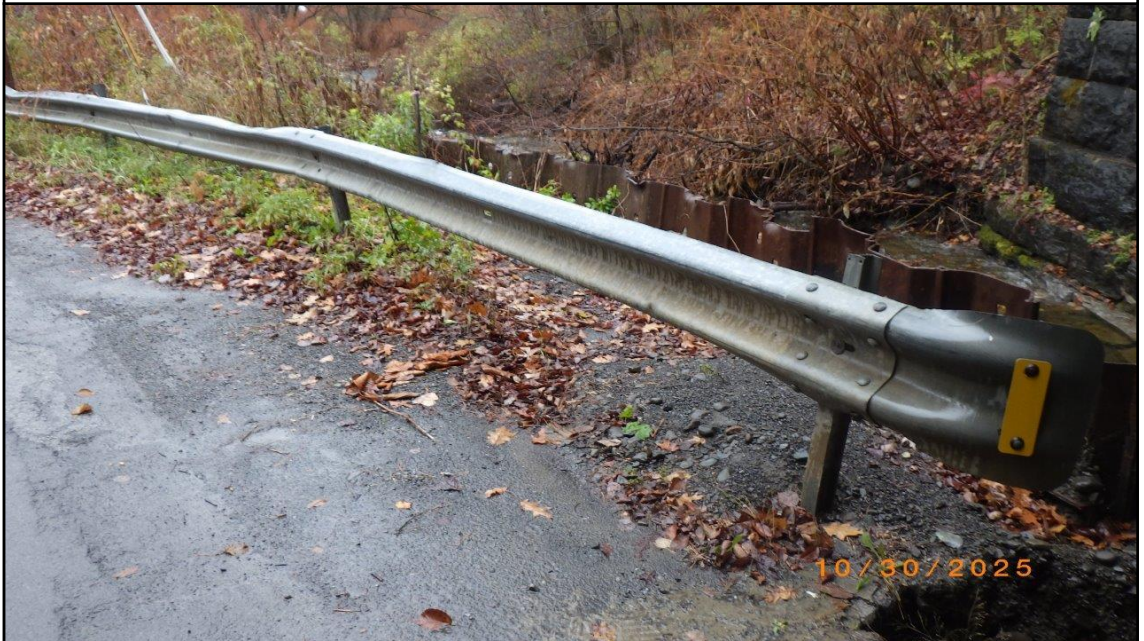
**Attachment Description:**  
End Left Approach Railing,  
At End, Looking Begin Left

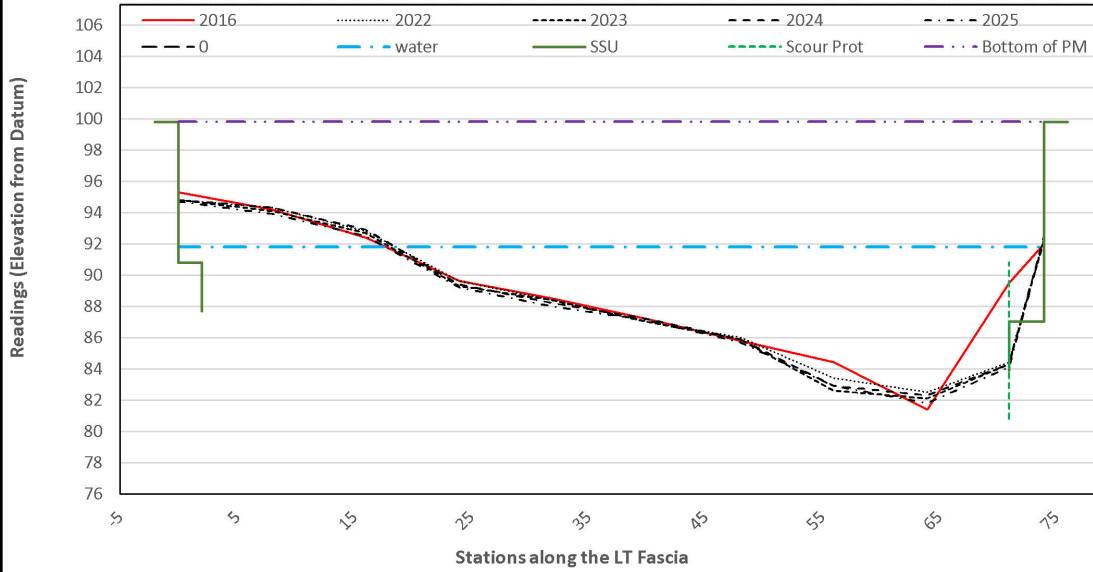
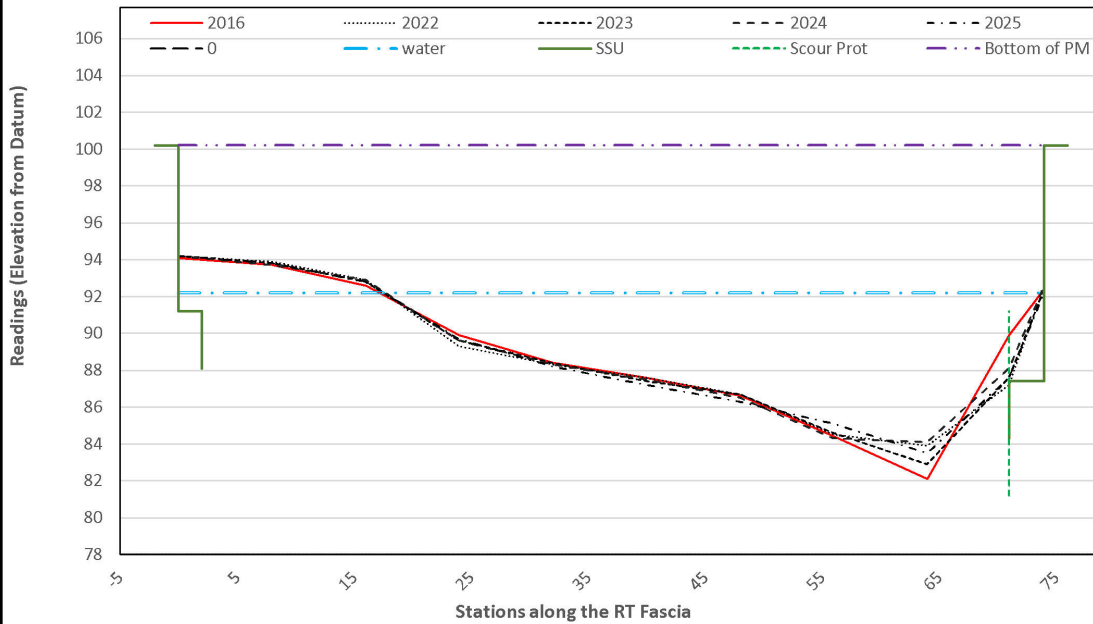
Date:	Comments
2016	Baseline readings please do not delete the data unless the channel was graded or the datum has been changed
2022	Right Fascia, aggradation 0.9 ft @ Sta. 7. Remaining stations have no significant changes.
2023	Degradation of 1.0' at Right Fascia, Sta. 64. Degradation of 0.8' at Left Fascia, Sta. 56. Otherwise no significant changes
2024	Aggradation of 1.2' at Right Fascia, Sta. 64. Otherwise no significant changes
2025	No significant Changes.
