# New York State Department of Transportation General Bridge Inspection Report

*Inspection Date:* October 30, 2025

*BIN:* 2227620

*Feature Carried:* LOFT ROAD

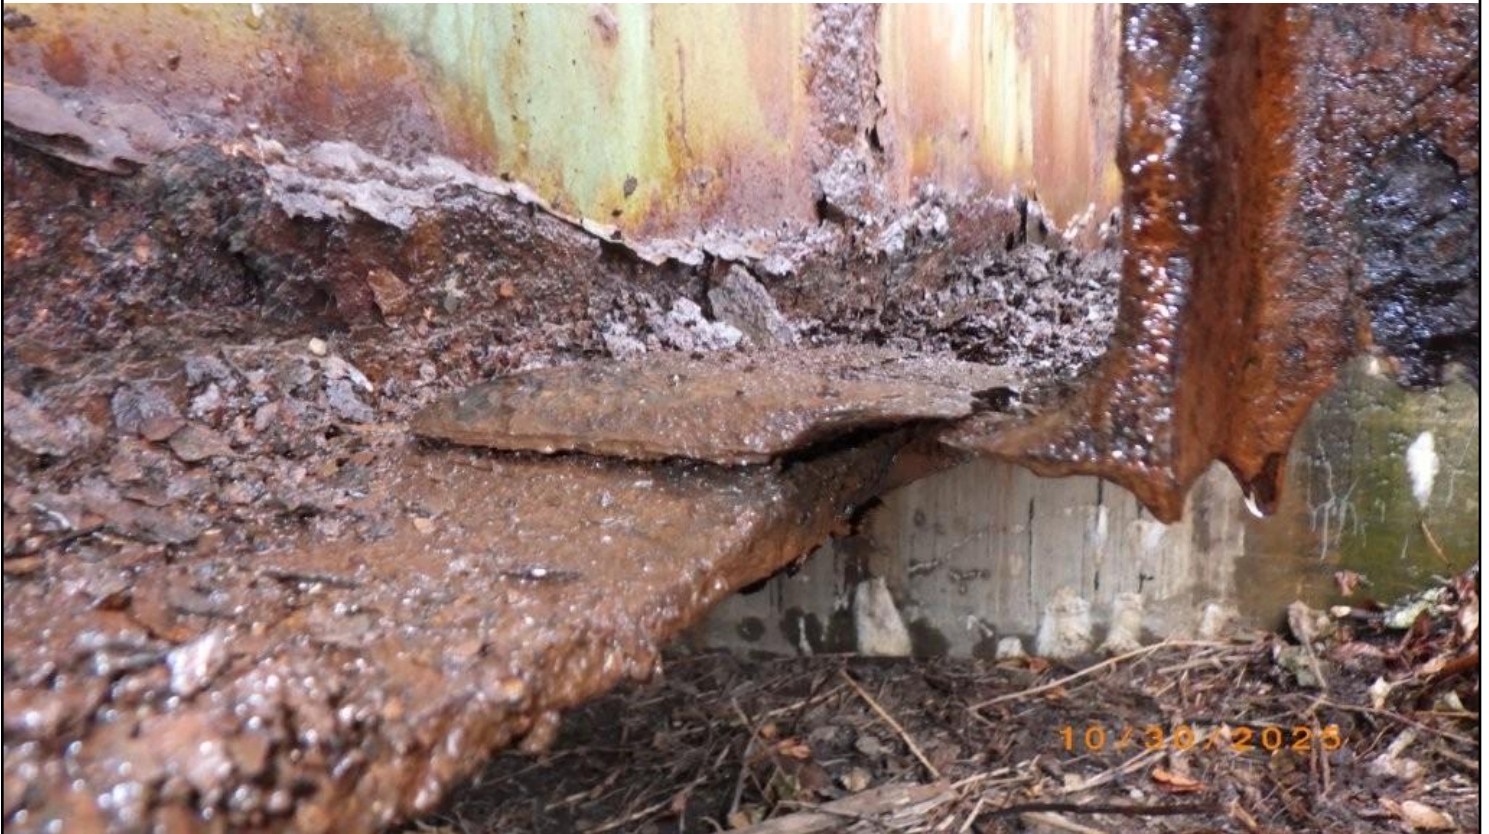
Photo Number: 1

- Left side, post 3: The weld is fully cracked on the left, right, end sides (Photo 1, Deteriorated from 2024).
- Left side, post 4: The weld is cracked 100% on the end side, 30% on left and right sides (Photo 2, New).
- Left side, post 5: The weld is cracked 100% on the end side, 50% on left and right sides (Photo 3, Deteriorated from 2024).
- Left side, post 7: The weld is cracked 100% on the end side, 25% on left and right sides (New).
- Left side, post 9: The weld is cracked 75% on the begin side (New).
- Right side, post 2: all welds are cracked on all sides but the connection remains firm and the welds may not be fully cracked thru (Photo 4, no changes).

Currently, there is no apparent propagation of the cracks into the girder base metal. Yellow 9B25V2W046 is reissued and supersedes Yellow Flag 9B23NQQW019.

Significance: The partially cracked connection welds are in the tension zone of the girders and have the potential to propagate into the base metal of the bottom flange of the fascia girders.

**Attachment Description: Left Bridge Rail Post 3, End Side, Looking Begin**

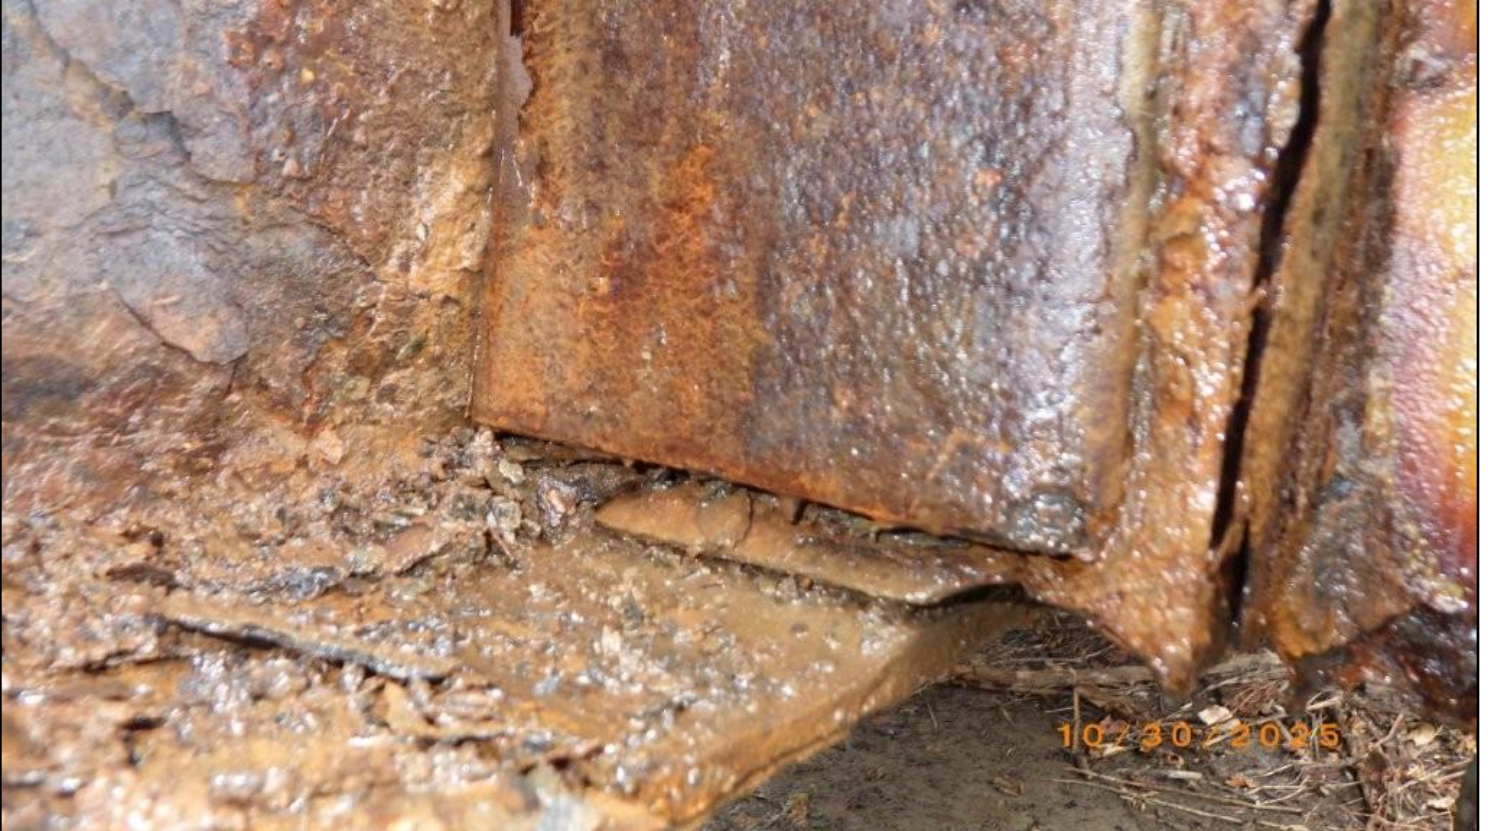
Photo Number: 2

***Attachment Description: Left Bridge Rail Post 4, End Side, Looking Begin Right***

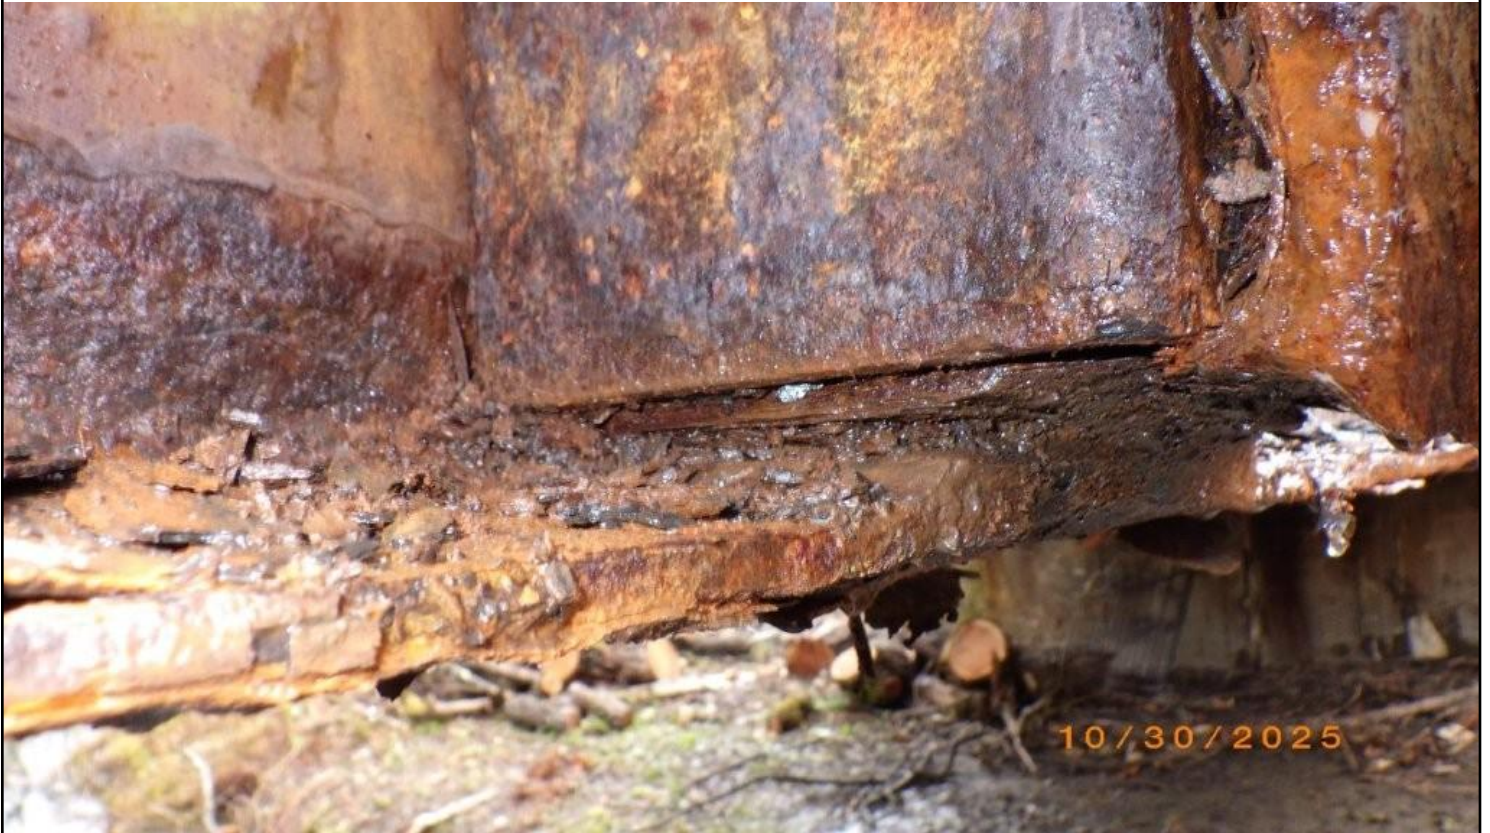
Photo Number: 3

***Attachment Description: Left Bridge Rail Post 5, End Side, Looking Begin Right***

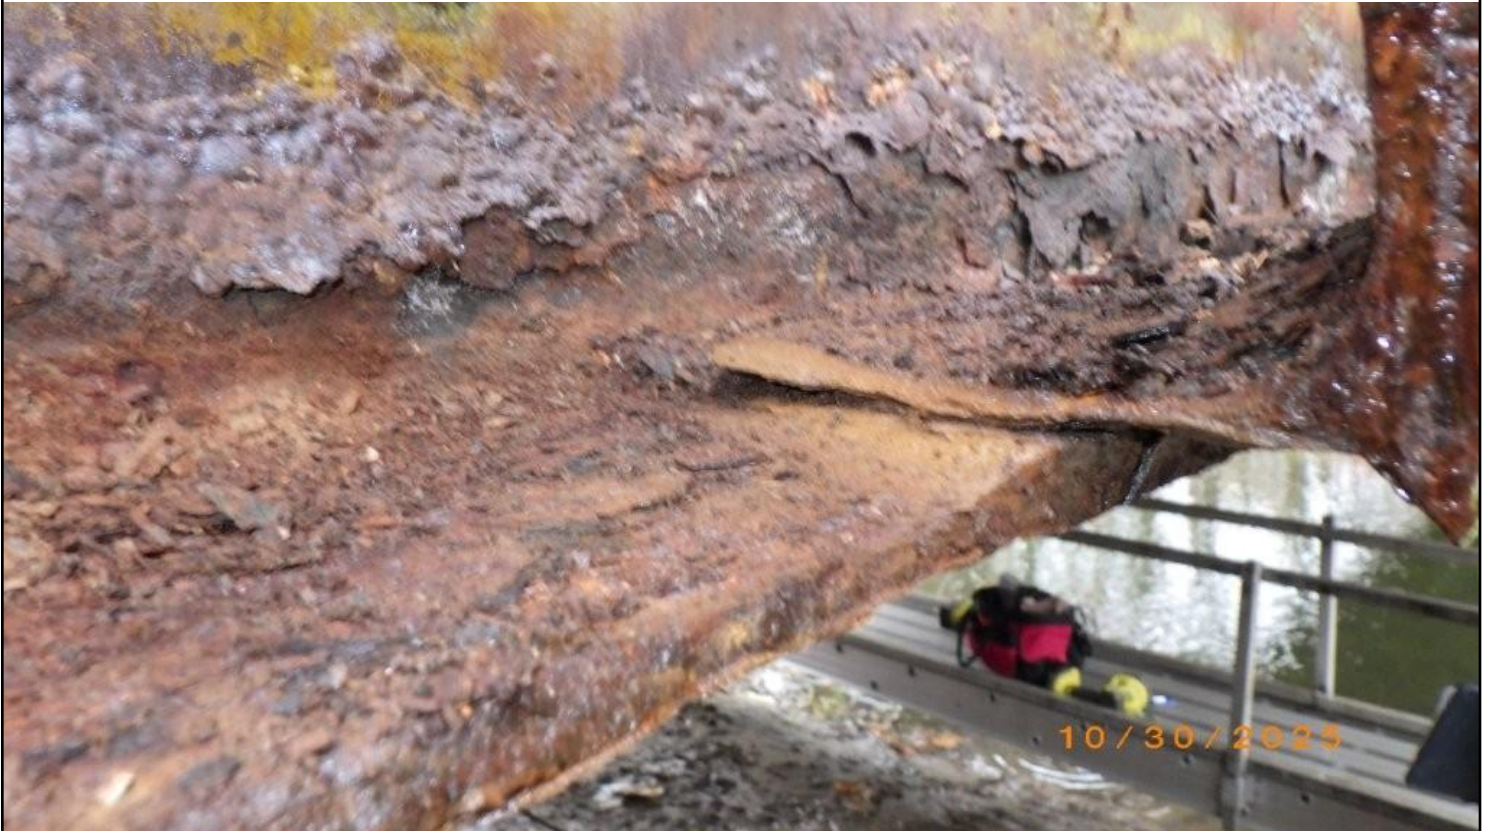
Photo Number: 4

***Attachment Description: Right Bridge Rail Post 2, Begin Side, Looking End Left***
