Re: Limited Hazardous Materials Survey
BIN 3350360 – County Route 32 Over Wheeler Brook
Greene, New York
ATL Report No. ET5403BCE-01-12-25

LIMITED HAZARDOUS MATERIALS SURVEY

**BIN 3350360 – COUNTY ROUTE 32 OVER WHEELER BROOK
GREENE, NEW YORK**

ATL REPORT NO. ET5403BCE-01-12-25

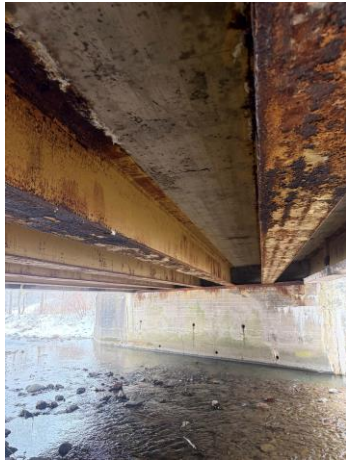
Material	General Location^{1, 2}	Friable/ ACM Type	% Asbestos	Condition	Sample Numbers	Estimated Quantity²
Yellow Paint	Bridge Girders	N/M	NAD	Fair	ET5403BAI01A ET5403BAI01B ET5403BAI01C	NA
Black Bearing Pad	Bridge Beams at Abutments	N/M	NAD	Fair	ET5403BAI02A ET5403BAI02B	NA

Photograph 1: View of yellow paint on bridge girders of subject bridge.

1. The material listed in bold in Table D-II of Appendix D were determined to be LBP per HUD criteria. Material in Table D-II is also regulated under OSHA (reference 29 CFR 1926.62).
2. Materials with a detectable concentration of lead should be managed in accordance with applicable EPA (40 CFR Part 745) and OSHA (29 CFR 1926.62) requirements prior to or during demolition, renovation, remodeling, or repair work.

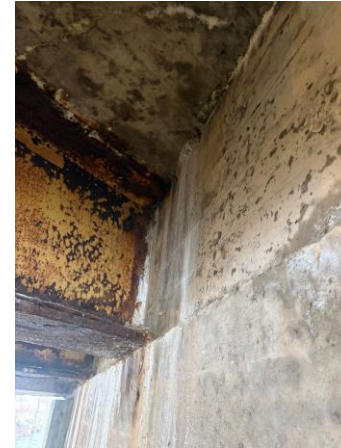
Photograph 2: View of back wall of subject bridge.
