# New York State Department of Transportation General Bridge Inspection Report

*Inspection Date:* October 30, 2025

*BIN:* 2227620

*Feature Carried:* LOFT ROAD

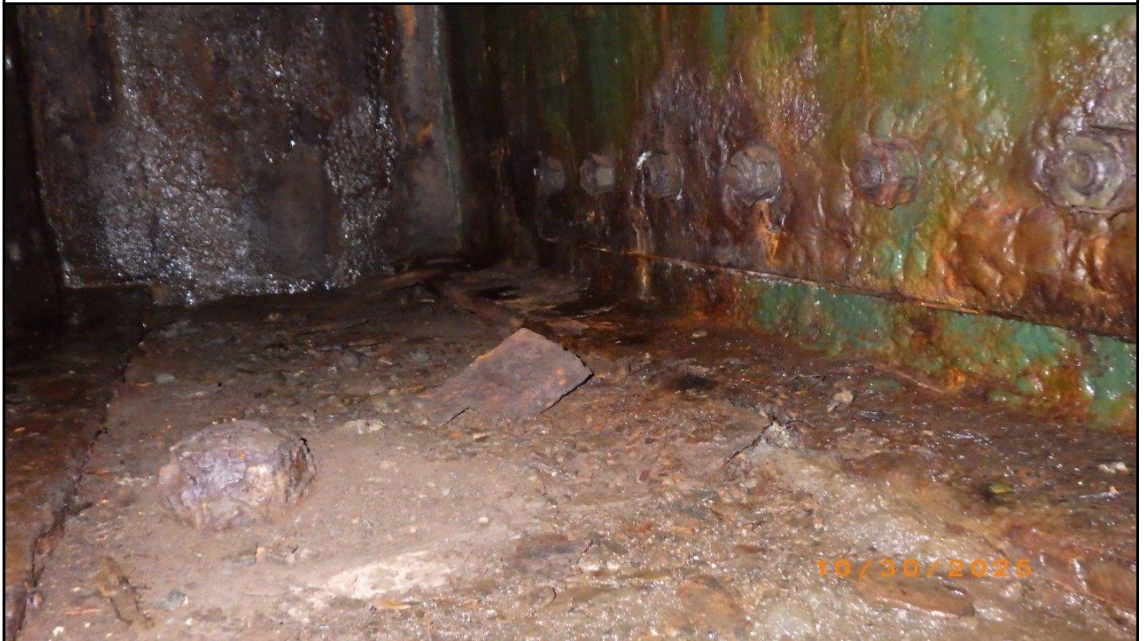
Photo Number: 21 Photo Filename: **IMGP3287.jpg**

All paint has failed on the end abutment bearings, allowing corrosion to form (Photo 21).

**Attachment Description:**  
End Abutment Girder G7  
Bearing, Looking End Right

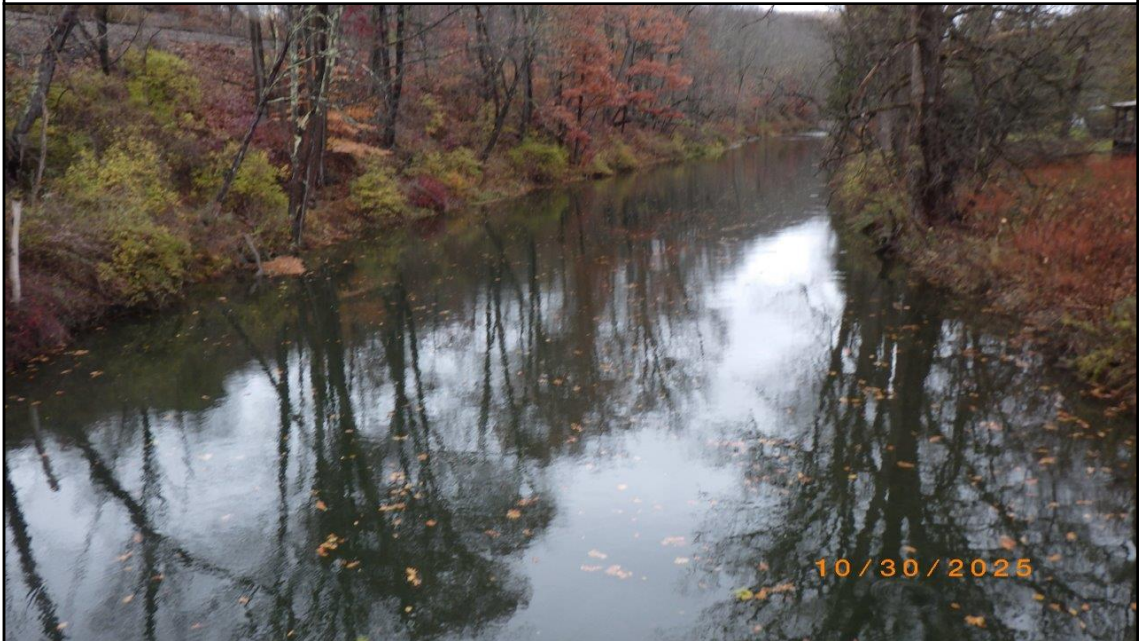
Photo Number: 29

**Attachment Description:**  
Feature Crossed Left,  
Downstream, Looking Left

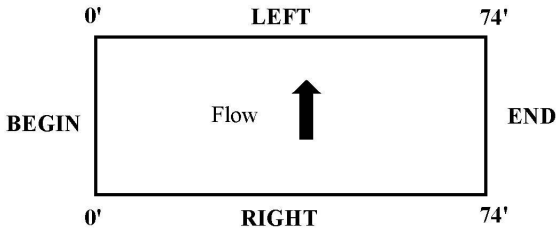
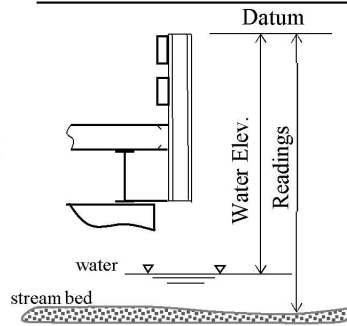
Date:	Comments
2016	Baseline readings please do not delete the data unless the channel was graded or the datum has been changed
2022	Right Fascia, aggradation 0.9 ft @ Sta. 7. Remaining stations have no significant changes.
2023	Degradation of 1.0' at Right Fascia, Sta. 64. Degradation of 0.8' at Left Fascia, Sta. 56. Otherwise no significant changes
2024	Aggradation of 1.2' at Right Fascia, Sta. 64. Otherwise no significant changes
2025	No significant Changes.

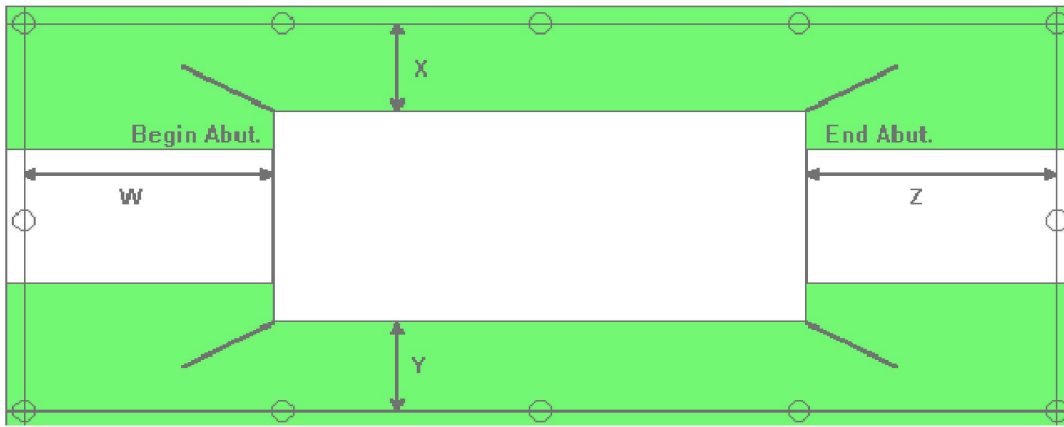
**Sketch Description:** Electrical Hazard Survey

<b>Electrical Hazard Classification</b>	<input type="checkbox"/>	Danger!
	<input checked="" type="checkbox"/>	Warning
	<input type="checkbox"/>	No Lines Present

<b>Electrical Hazard Alignments</b>	<input checked="" type="checkbox"/>	Parallel Alignment
	<input checked="" type="checkbox"/>	Perpendicular Alignment
	<input type="checkbox"/>	Diagonal Alignment

<b>Utility Name</b>	UNKNOWN
<b>System Voltage</b>	UNKNOWN

Location (Put X where appropriate)		No Lines Present	Above the Deck	Below the Deck	Above and Below	Horizontal Offset (ft)	Vertical Offset (ft)
Before Begin Abutment	(W)		X			70	15
To Left of Bridge	(X)		X			4	15
To Right of Bridge	(Y)	X					
After End Abutment	(Z)		X			50	15

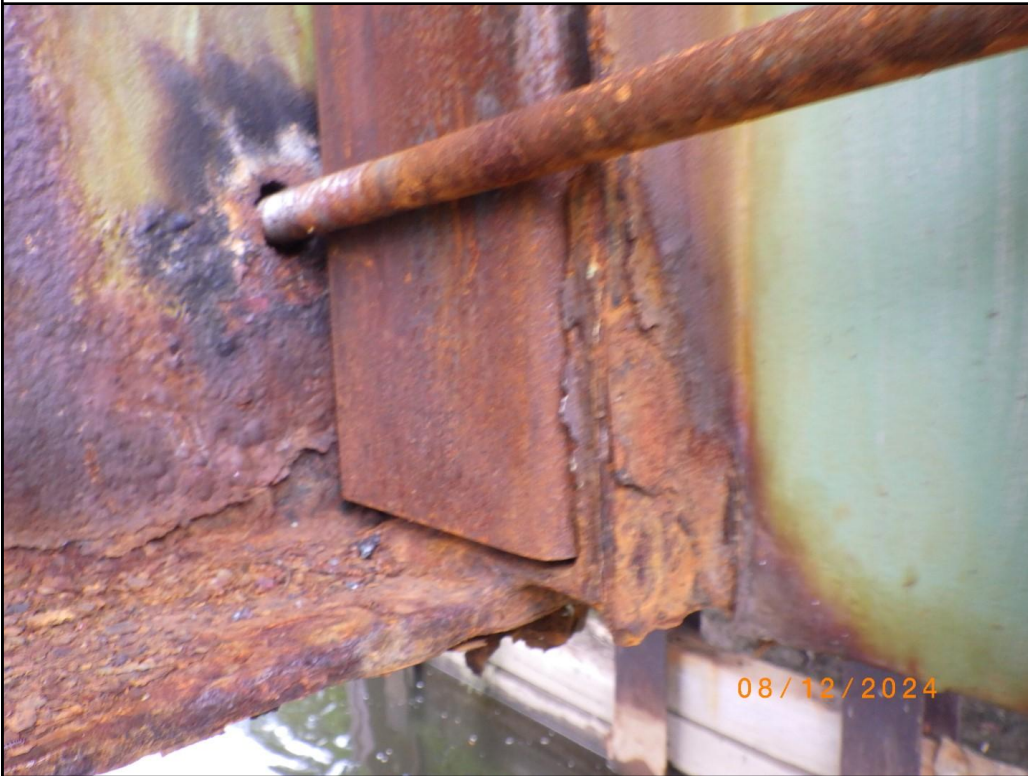
Special Emphasis Detail- Railing Bottom Flange Welds.JPG

Flag conditions: Long-standing and newly reported cracked connection welds between bridge rail post clip angle brackets and fascia girder bottom flanges, in tension zones of the girders.

There are cracked connection welds between the bridge rail post clip angle bracket and the fascia girder bottom flange at locations below:

- Left side, post 3: The weld is fully cracked on the left, right, end sides (Photo 1, Deteriorated from 2024).
- Left side, post 4: The weld is cracked 100% on the end side, 30% on left and right sides (Photo 2, New).
- Left side, post 5: The weld is cracked 100% on the end side, 50% on left and right sides (Photo 3, Deteriorated from 2024).
- Left side, post 7: The weld is cracked 100% on the end side, 25% on left and right sides (New).
- Left side, post 9: The weld is cracked 75% on the begin side (New).
- Right side, post 2: all welds are cracked on all sides but the connection remains firm and the welds may not be fully cracked thru (Photo 4, no changes).

Currently, there is no apparent propagation of the cracks into the girder base metal. Yellow 9B25V2W046 is reissued and supersedes Yellow Flag 9B23NQQW019.

Significance: The partially cracked connection welds are in the tension zone of the girders and have the potential to propagate into the base metal of the bottom flange of the fascia girders.
